Humidity Generation and Calibration Equipment

Model 2500

Memory Card Issues

Tech Support Document TSD-0240
Revision Date: July 19, 2005

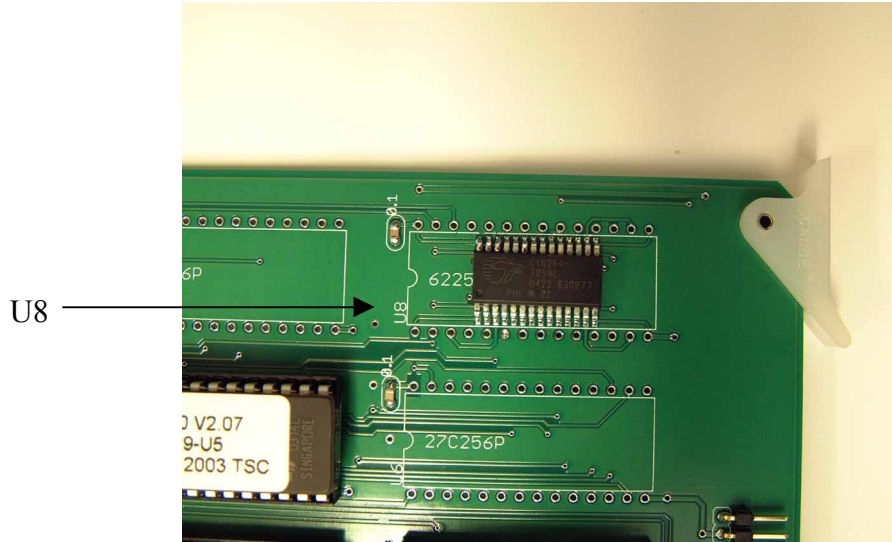
SMALL/SOLDERED = IC has tendency to drain battery backup prematurely.

If your memory card has either of these conditions, contact Thunder Scientific Corporation for an exchange replacement memory card.

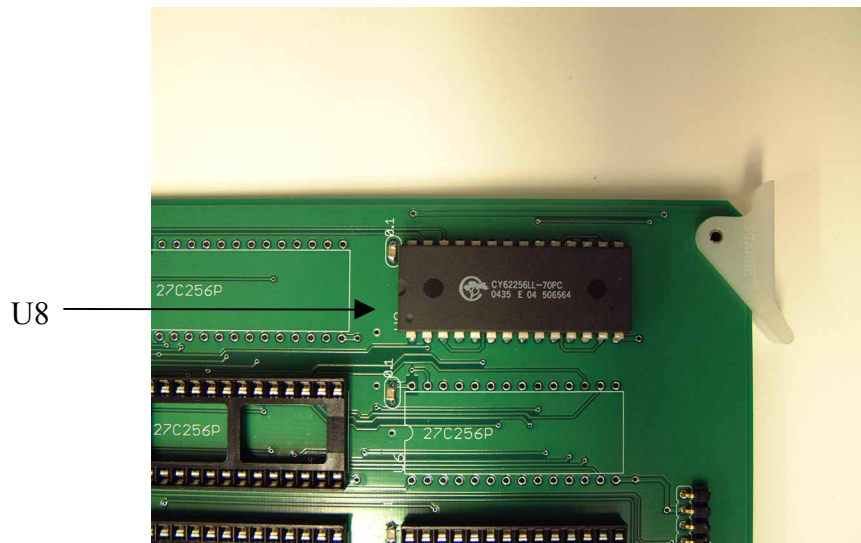
LARGE/SOLDERED = May have intermittent boot up issues.

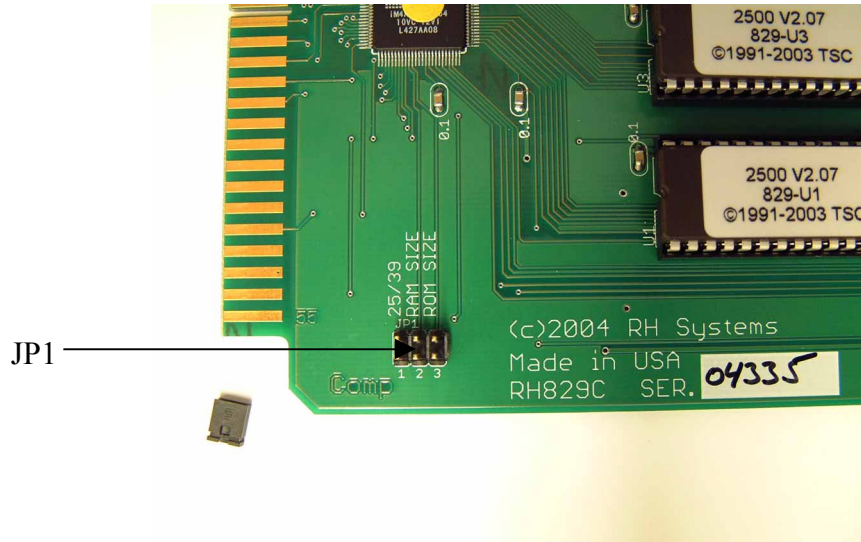
Also examine jumper location JP1. If jumper pins are present, is there a jumper across row #2?

PRESENT = Jumper has tendency of falling off.

MISSING = Unit will not boot properly.
